BROWNFIELD REDEVELOPMENT ASSESSMENT REPORT

CARTER COLOR COAT
(formerly GMC Fisher Body Plant 21)

DETROIT, MICHIGAN

April 30, 1997

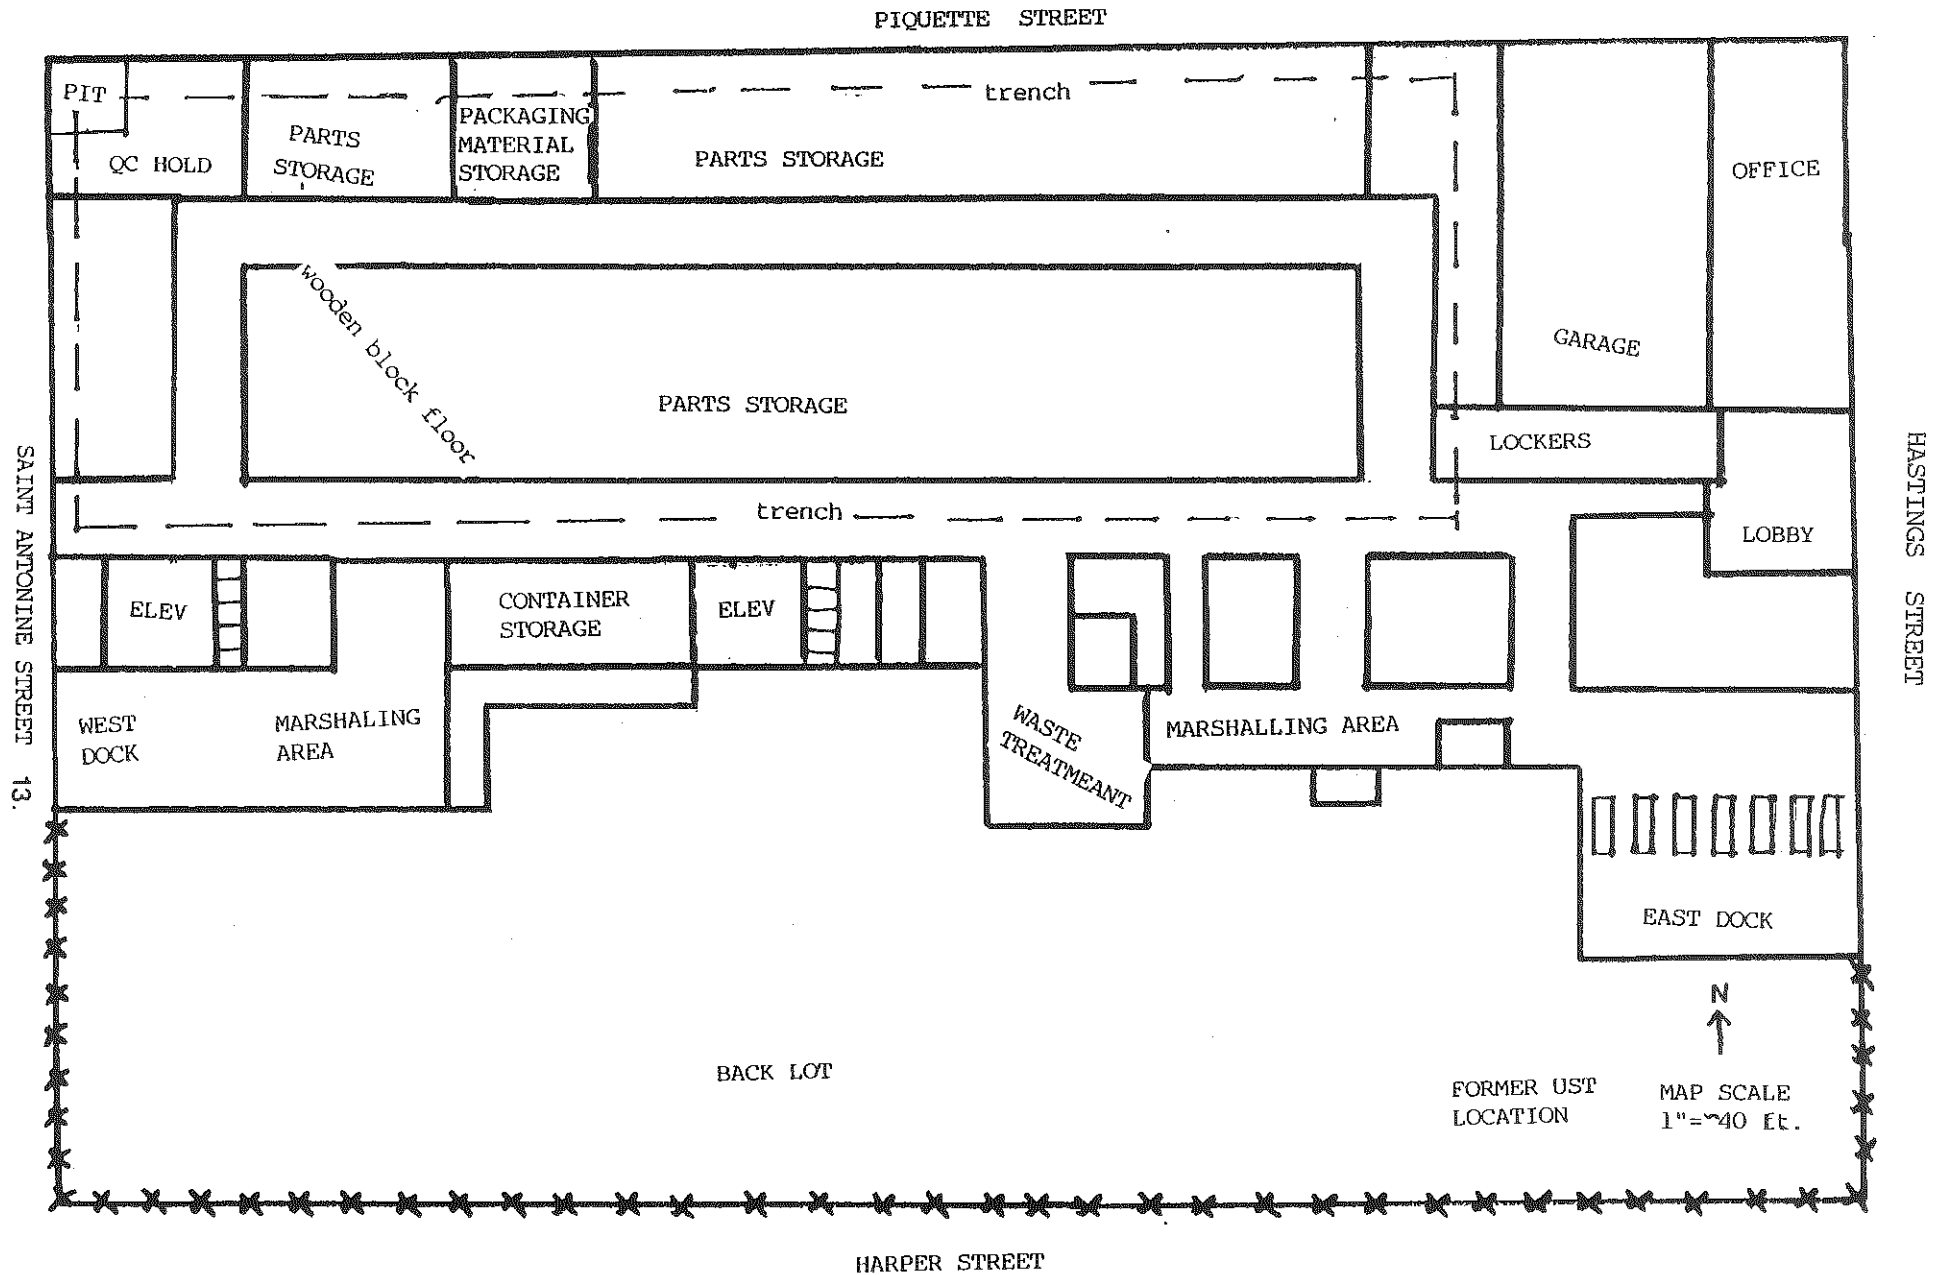
FIGURE 2 PROPERTY FEATURES MAP GROUND FLOOR

- Stained and discolored wooden block flooring covered the western half of five of the six floors of the building;
- A trench, approximately three feet wide and four feet deep encircled the ground floor in which sedimentation and other debris were deposited;
- A large pit, of unknown dimensions, is located in the northwest corner of the ground floor;
- Seven rectangular pits, several of which contained oil fluids and water, were located in the east dock truck receiving area on the ground floor;
- Approximately twenty five drums and barrels were observed on the ground floor in the waste storage area;
- Potential asbestos containing material (PACM) in the office and industrial areas on all six floors of the building;
- PACM in pipewrap mud joints and around pipes was observed on all six floors along with PACM in electrical insulation material on the fifth floor;

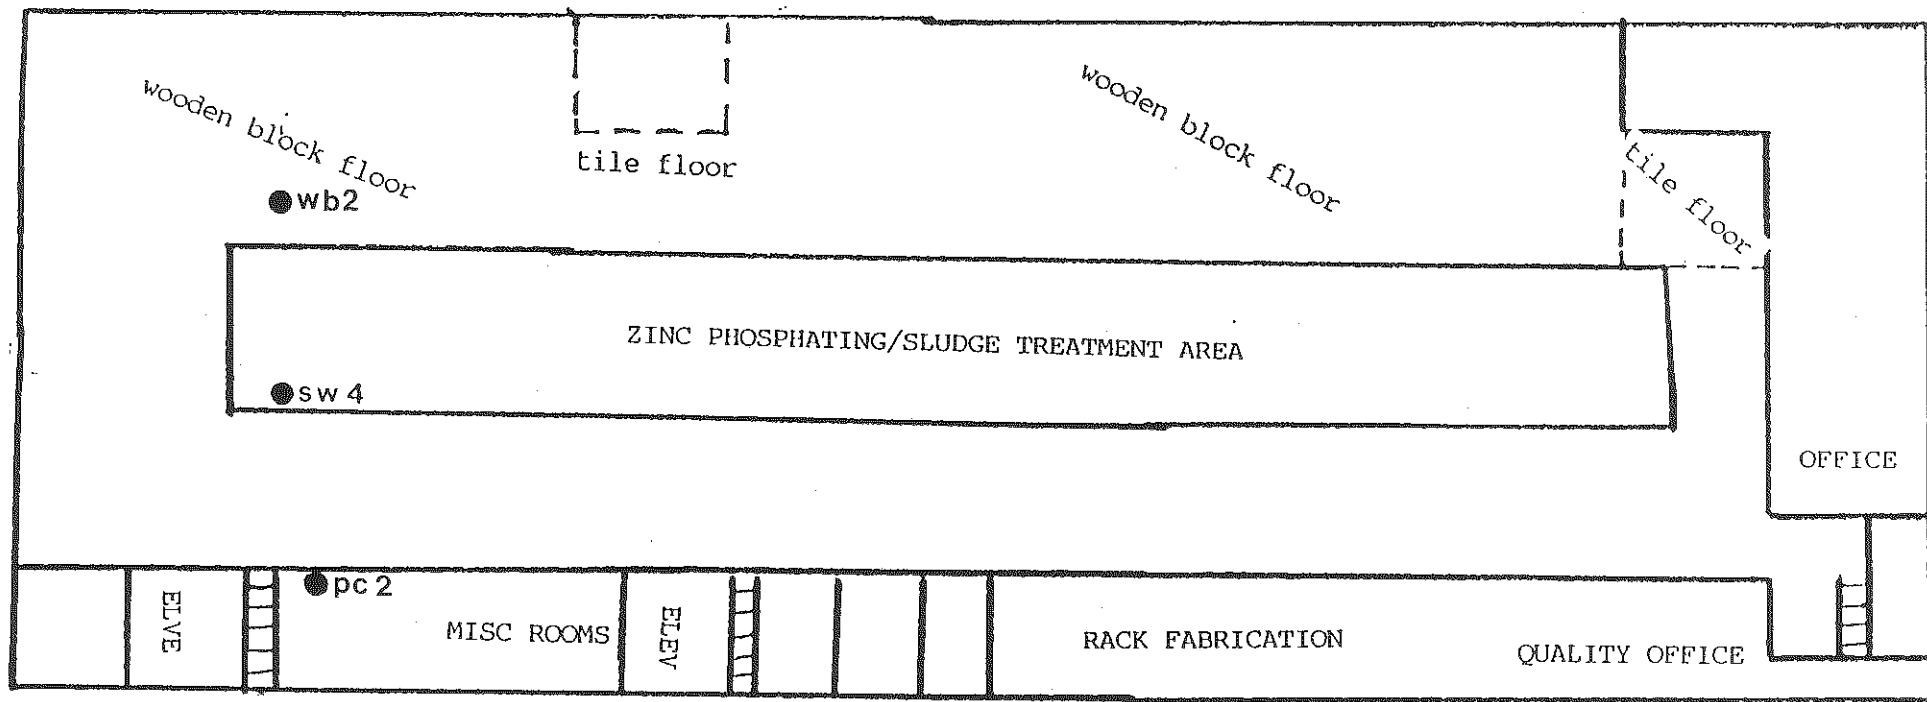
FIGURE 4 SAMPLING LOCATIONS SECOND FLOOR

All surface water samples were collected by direct immersion of the sample bottle into the water according to the procedures outlined in the work plan. See Figures 3 and 4 for the maps showing surface water sample locations. Surface water sample location and characteristic descriptions can be found in Table 3. Analysis of the surface water samples detected no contaminants in concentrations which exceeded either the Generic Residential or Industrial Cleanup Criteria for Direct Contact values of NREPA. Therefore, a summary table of the surface water sample analysis was not developed for this report.

SAMPLE #	LOCATION	APPEARANCE	COND.	DEPTH	DESIGNATION
			(μ s/cm) pH TEMP.(°C)		
SW3	Collected from Bay in truck delivery area in the southeast corner of the building	Clear water with tan to brown colored oil skimming the surface	Data not available		Grab sample
SW4	Collected from zinc phosphating trench area on the second floor	Rust colored water	Data not available		Grab sample
SW4D	Collected from zinc phosphating trench area on the second floor	Rust colored water	Data not available		Grab sample
